# Bath Township's

## Bath Creek Floodplain / Wetland Restoration

**PROJECT NUMBER 11(h)EPA-07**

**Environmental Results:** Successful completion of the project will restore a 12-acre degraded wetland & 1,700 feet of tributary stream flowing into Bath Creek. The restoration effort is expected to reduce flooding and improve overall water quality in the Yellow Creek watershed.

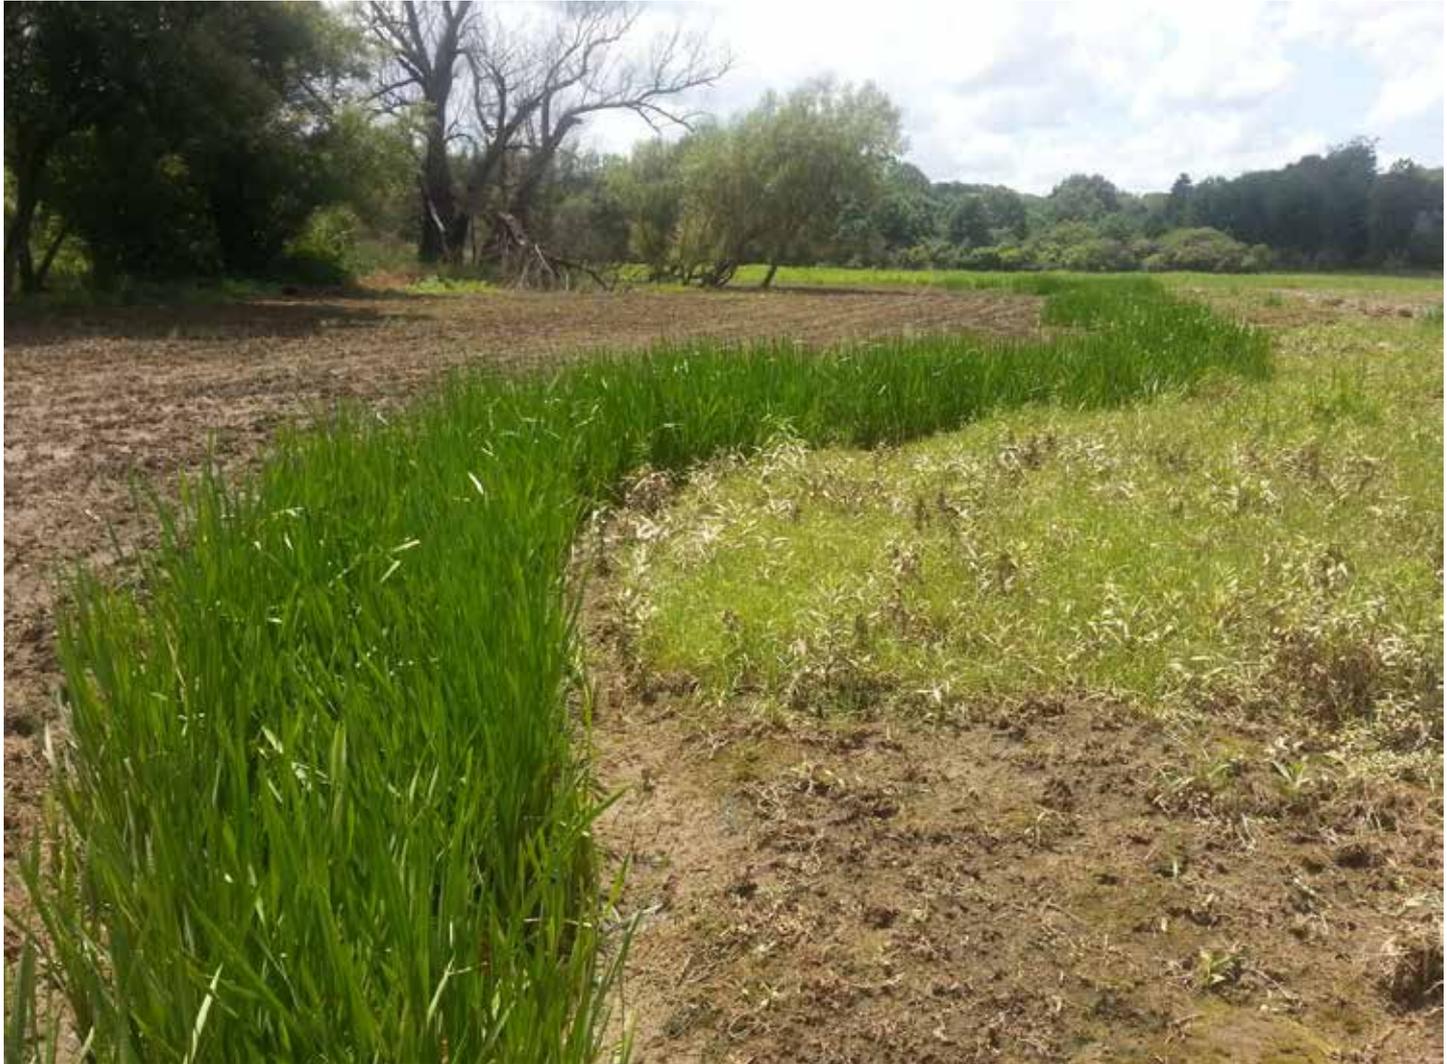
**July 2013 - Moore's Meander with Burr Reed *Sparganium americanum*  
Naturally Growing Throughout it's Channel**

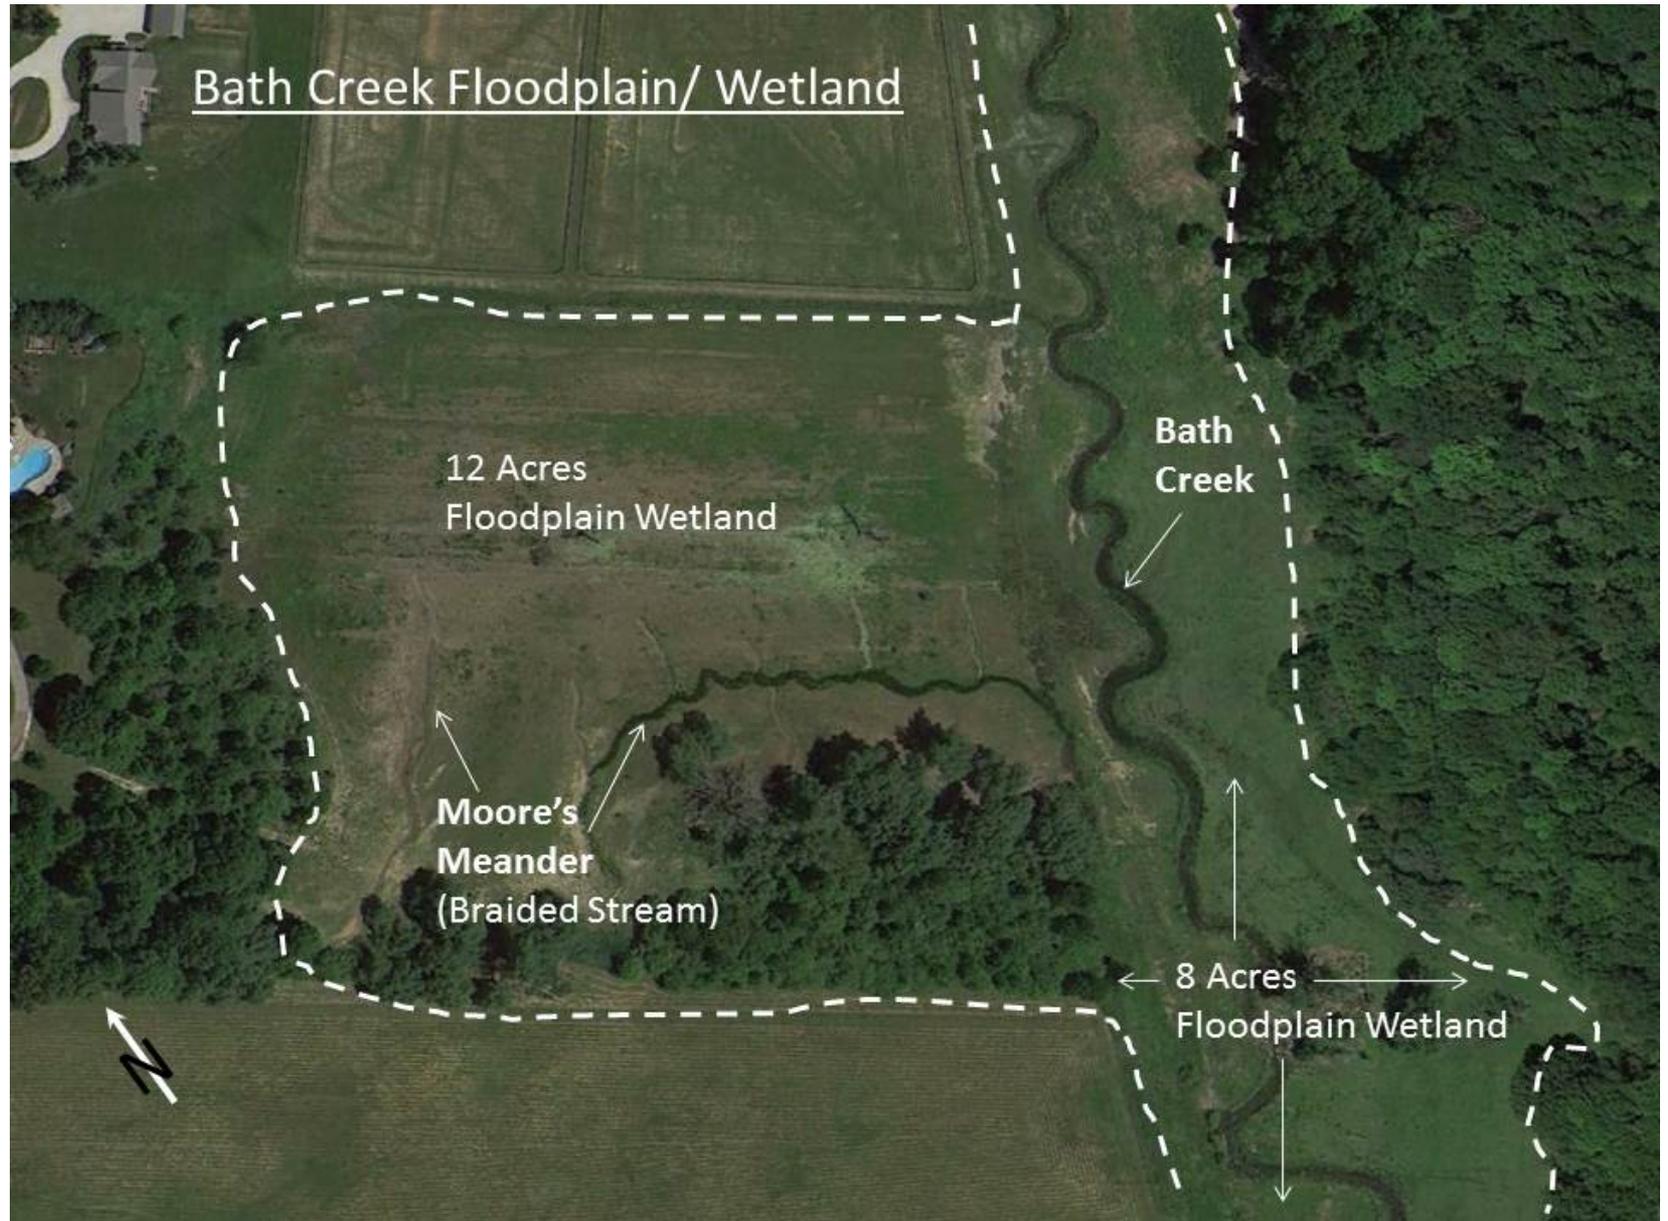
Bath Creek Floodplain/ Wetland

12 Acres  
Floodplain Wetland

Bath  
Creek

Moore's  
Meander  
(Braided Stream)

8 Acres  
Floodplain Wetland

- The Moore's Chapel Wetland has a ditched tributary of Bath Creek along the southern edge of the property. To restore the hydrology Bath Township had the stream re-configured by meandering it toward the center of the site (Moore's Meander). To ensure the site receives as much water as possible, multiple meandering channels were added running off of Moore's Meander. This design is called a "braided stream" or an Anastomose stream - meaning the interconnection between parts of any branching system.
- To ensure constant moisture to the site throughout the year a water control device was installed at the confluence of Moore's Meander and Bath Creek.

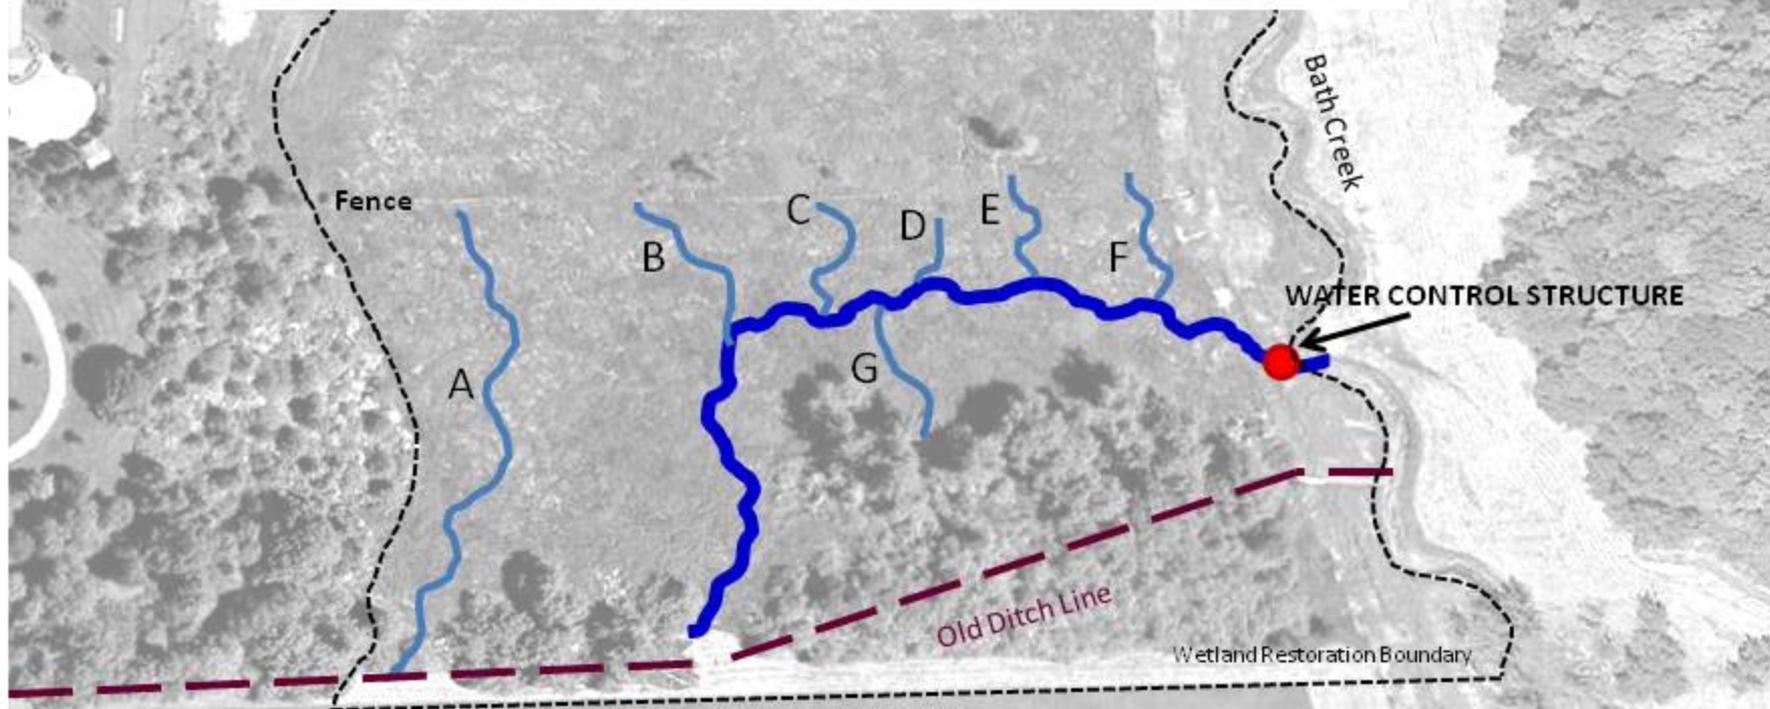
# MOORE'S CHAPEL FLOODPLAIN/ WETLAND RESTORATION

**Restored 1745 linear feet of stream.**

• Moore's Meander = 736 Feet

Tributary A = 410 feet    Tributary E = 97 feet

Tributary B = 126 feet    Tributary F = 118 feet

Tributary C = 102 feet    Tributary G = 113 feet

Tributary D = 43 feet

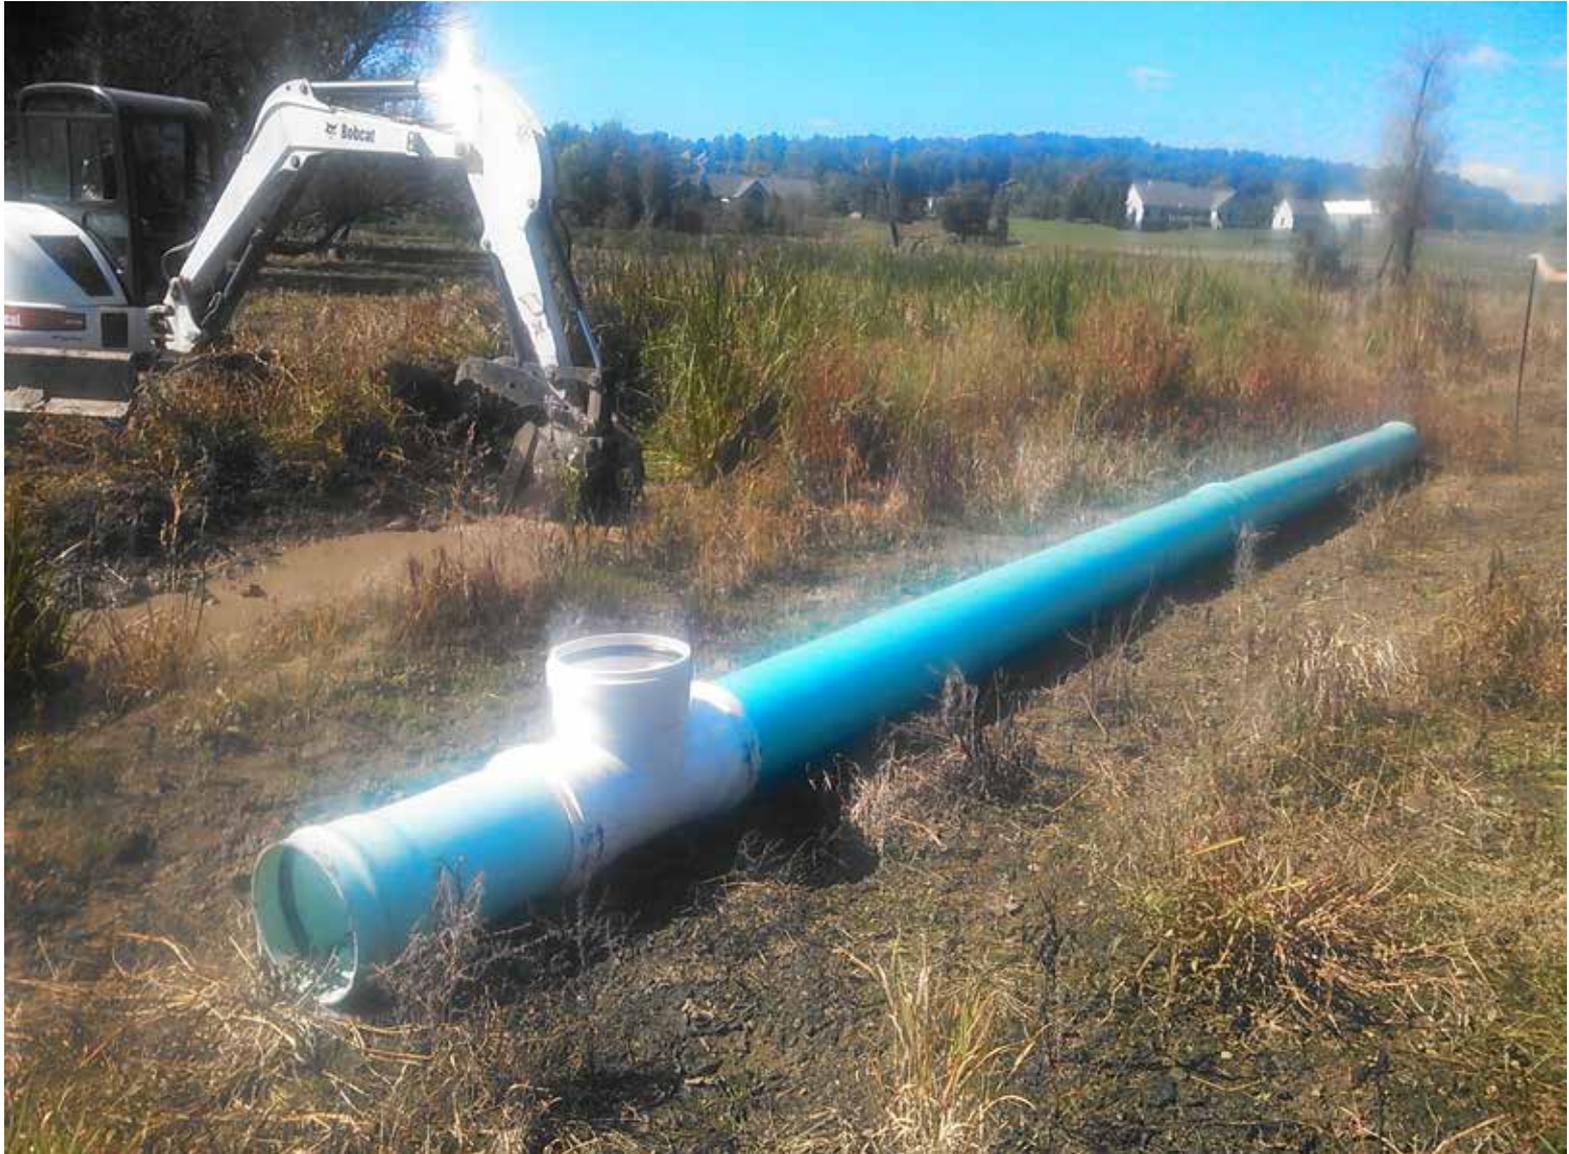
# Installation of Water Control Feature with Vertical Outlet

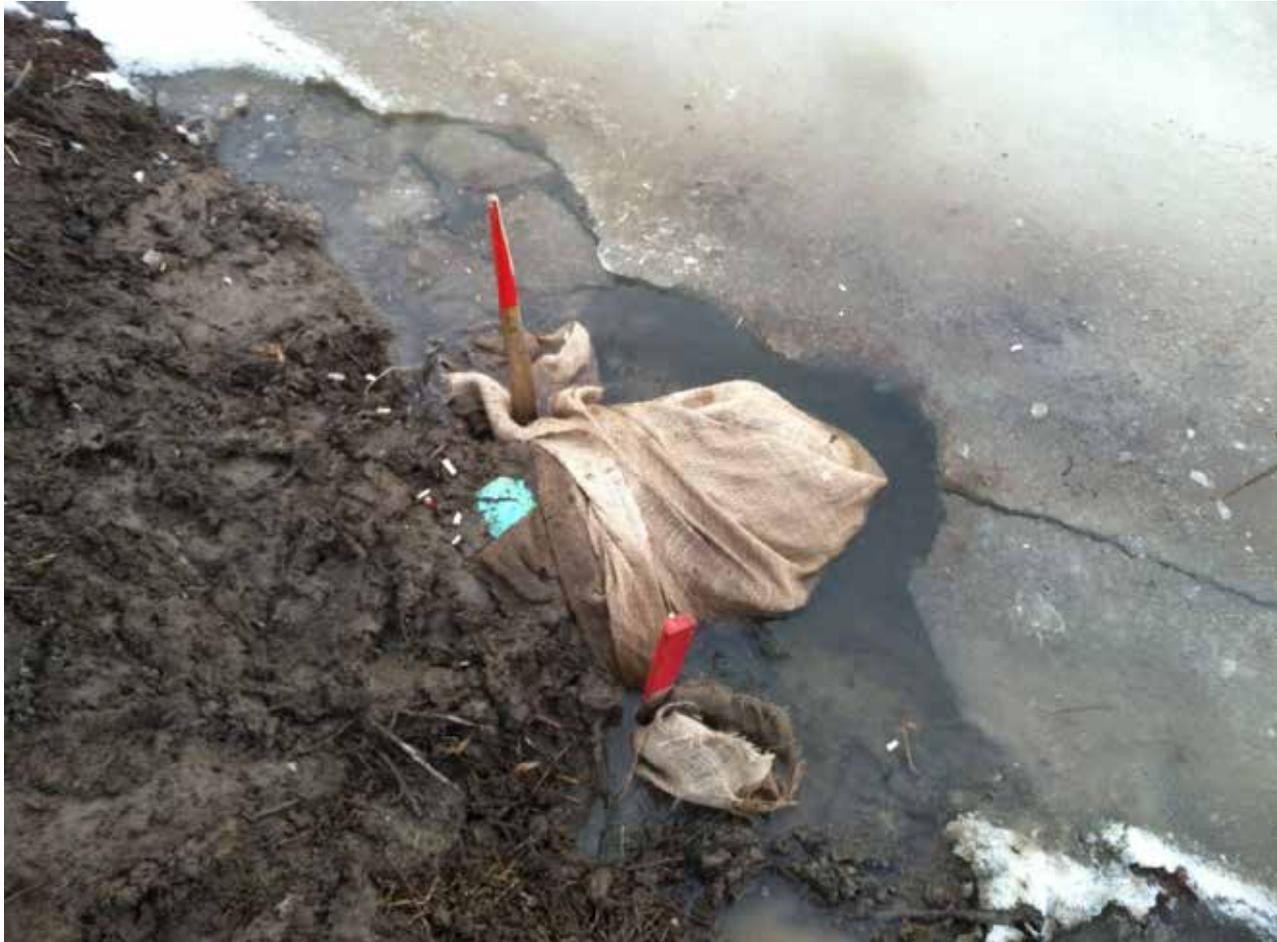
# **Inlet of Water Control Feature Wrapped with Burlap to Prevent Wetland Seeds from Washing Off Site**

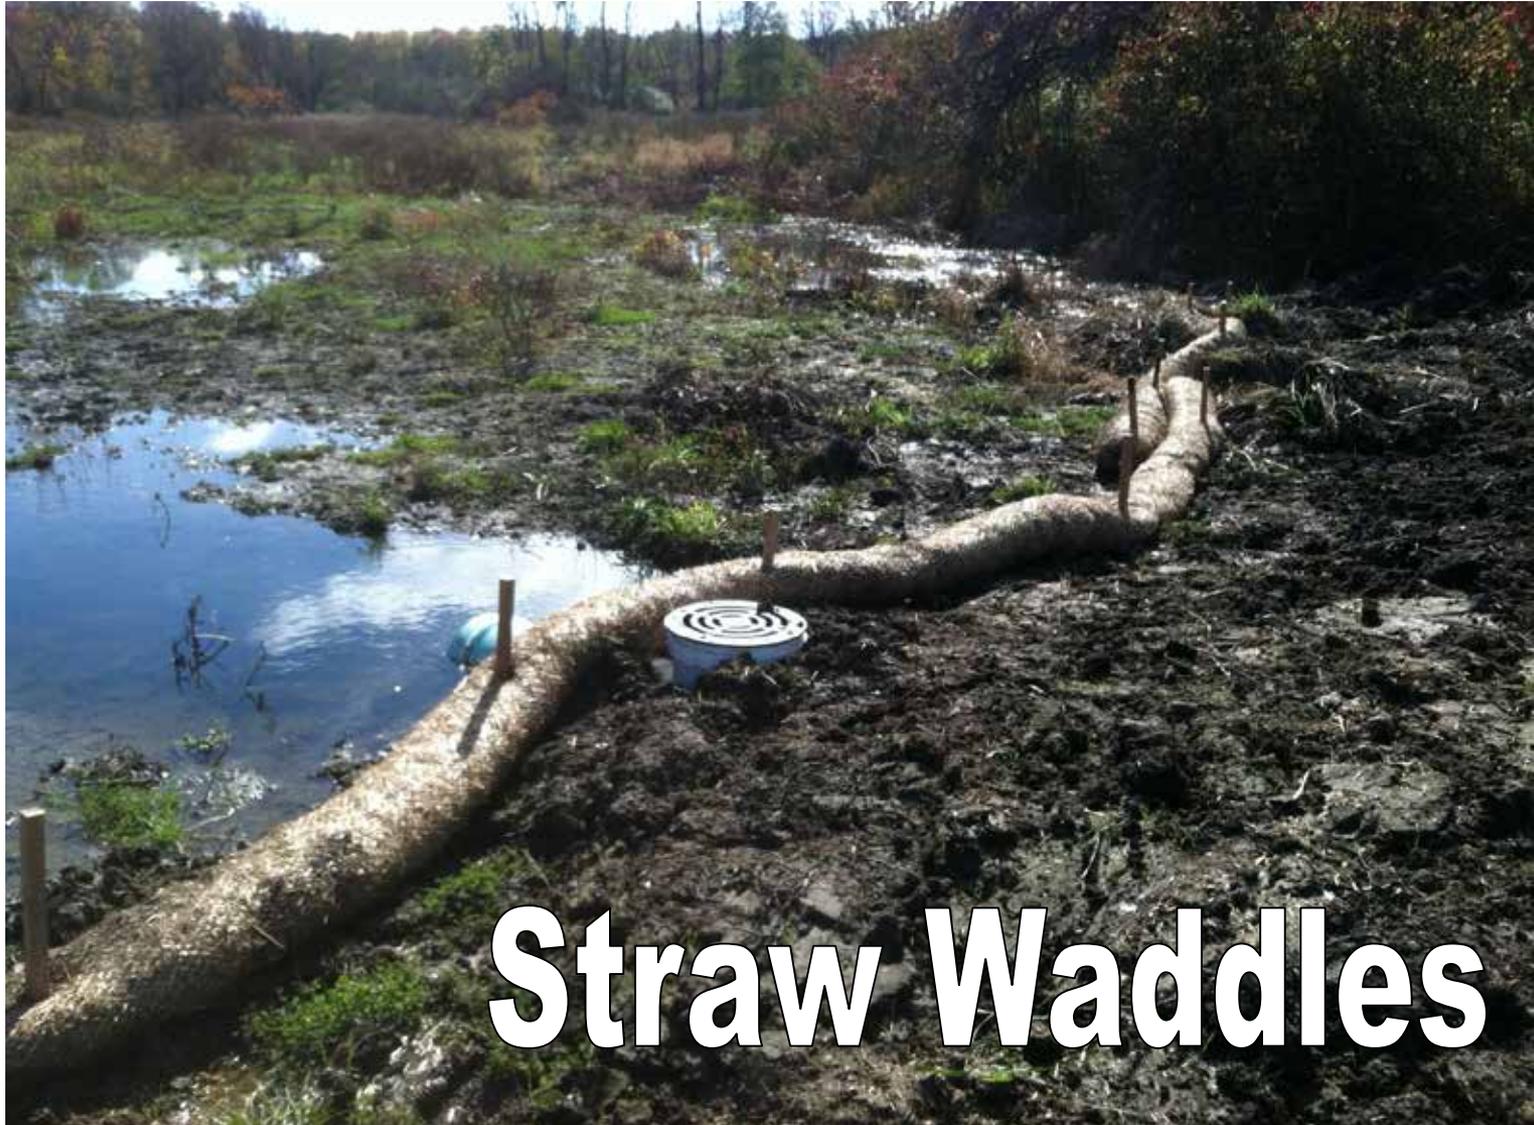
# **BMP's - During Construction**

**Straw Waddles**

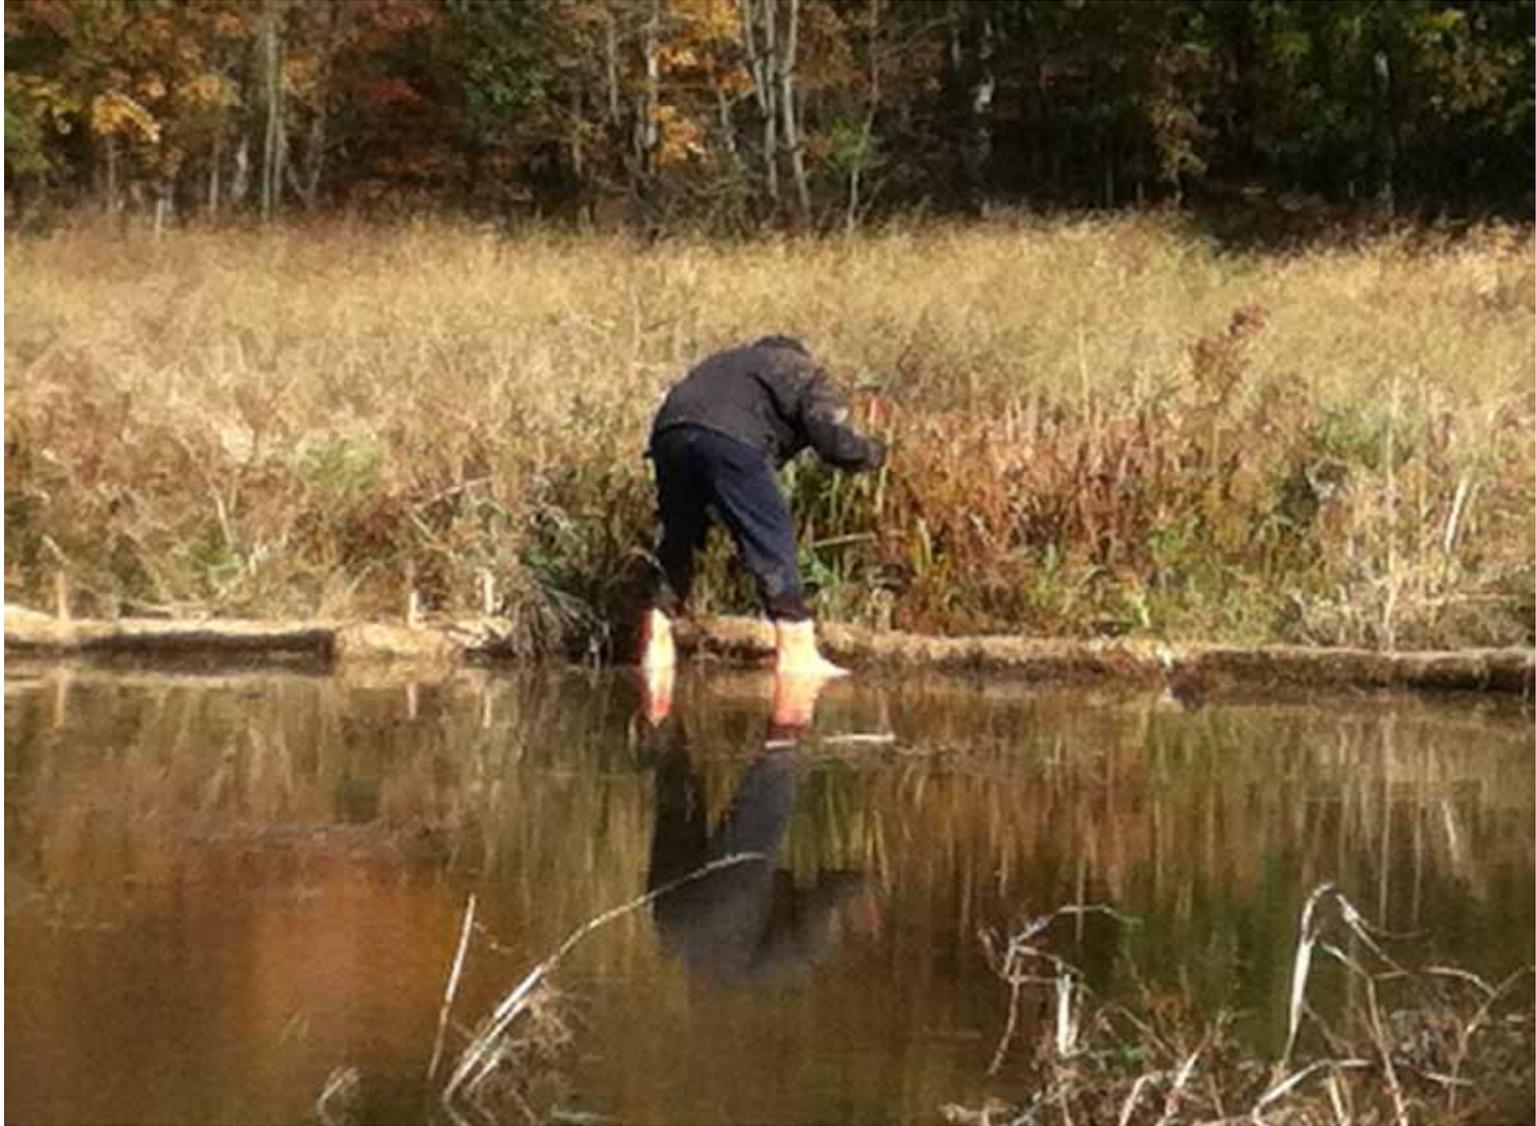
# Monthly BMP Inspections of Straw Waddles

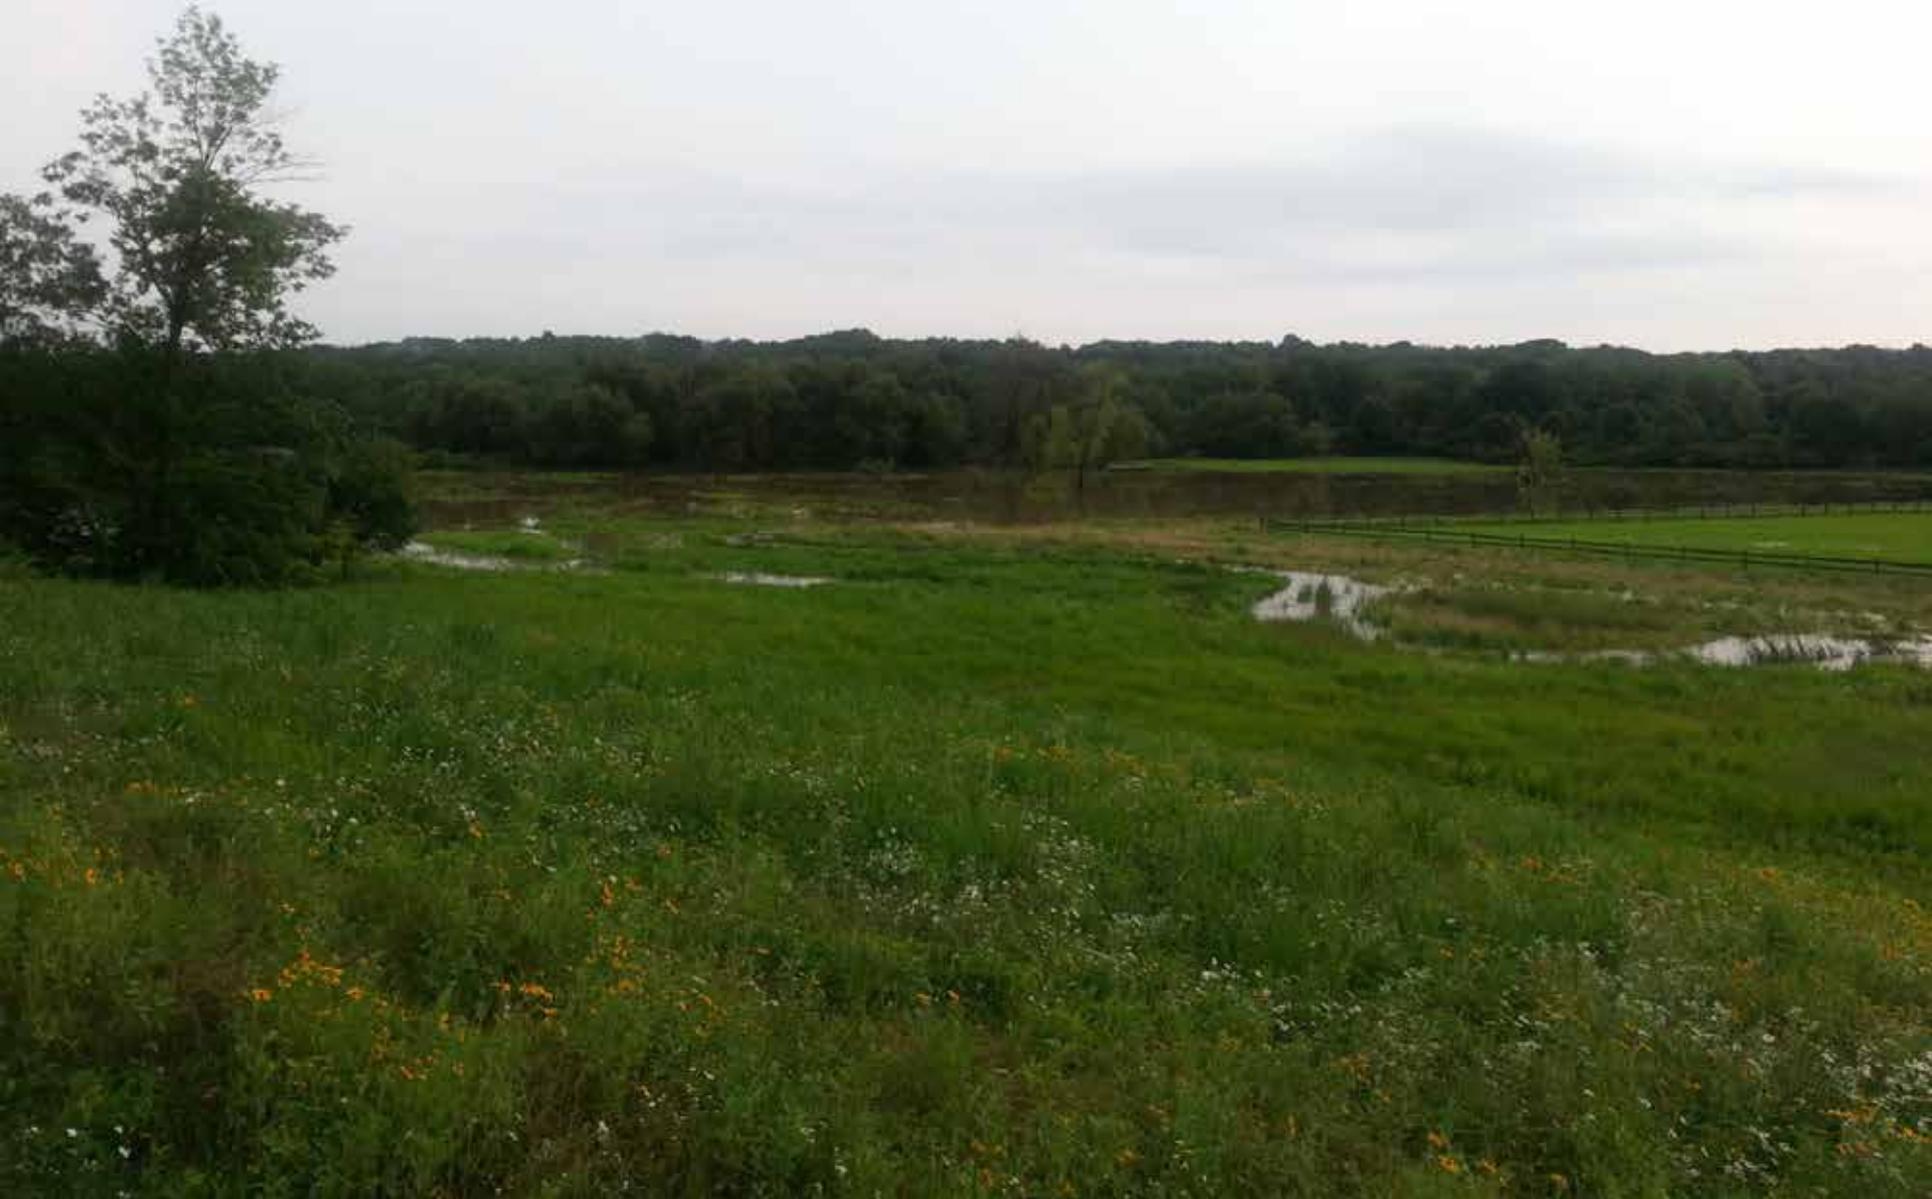
# **Flooding from July Flood Event 7/16/2013**

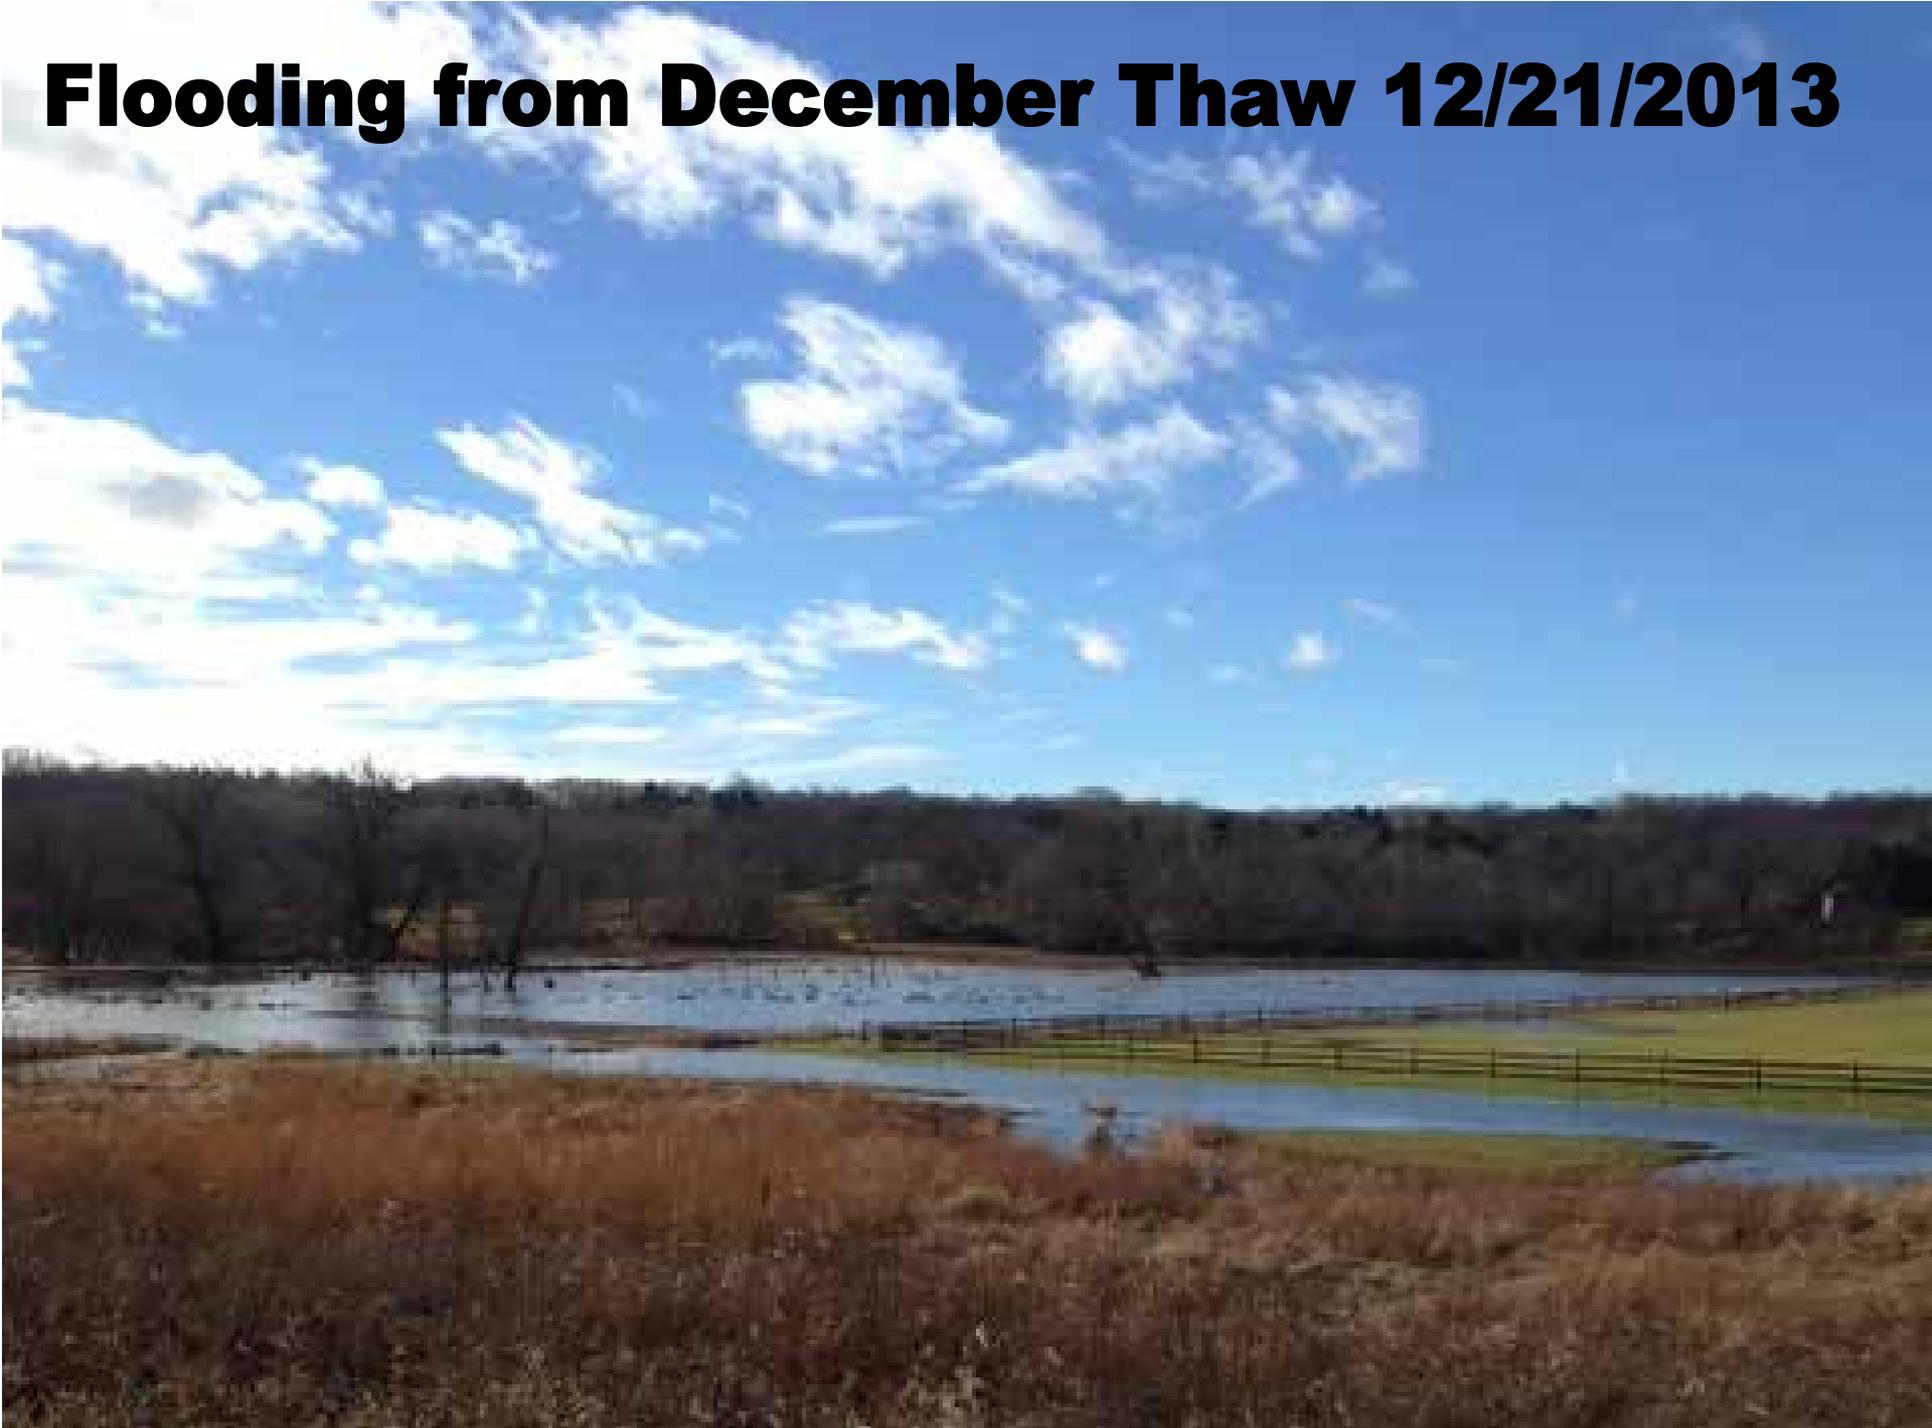
# **Flooding from December Thaw 12/21/2013**

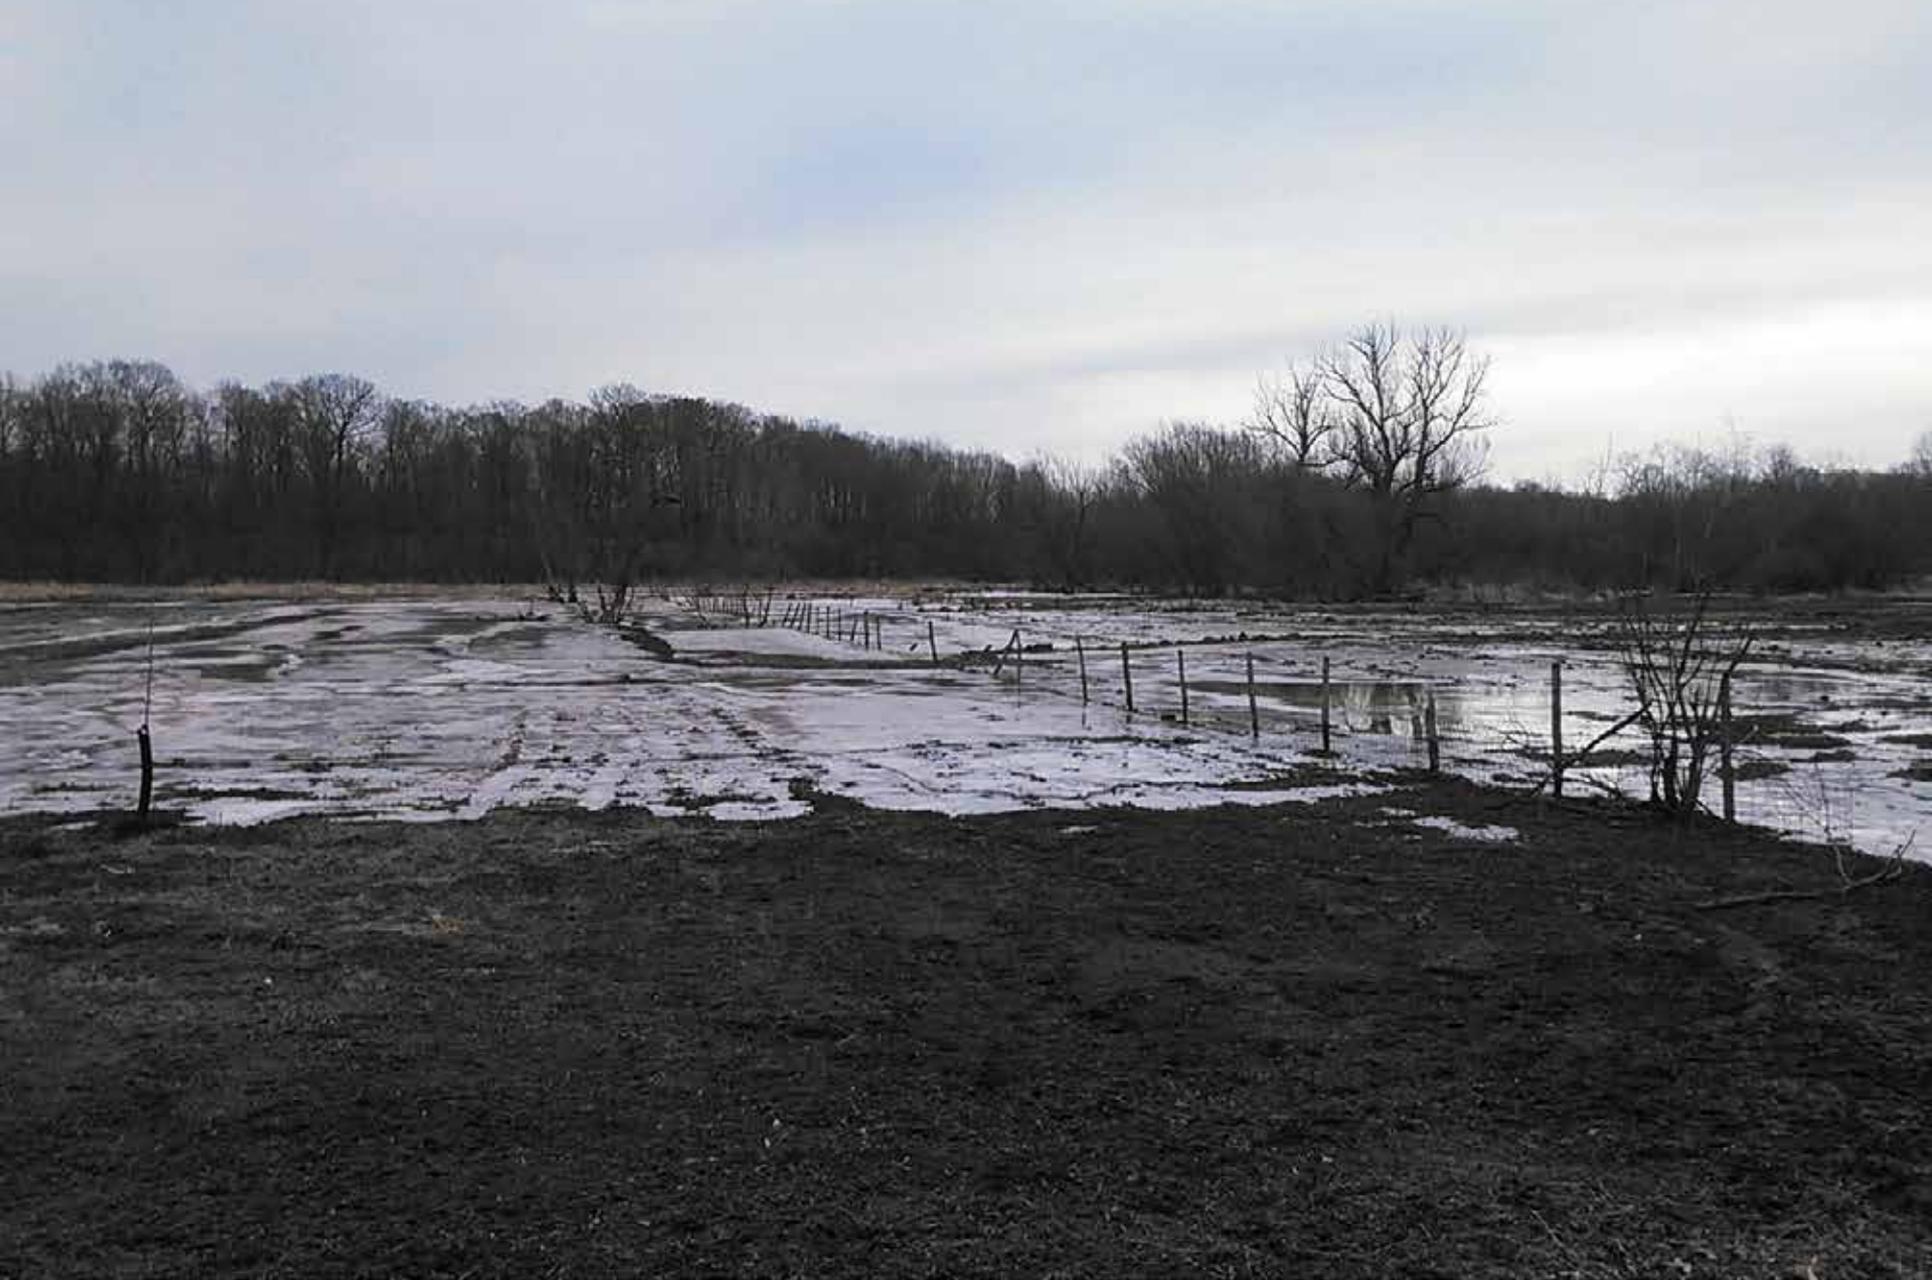
# Flooding from January Thaw 1/13/2014

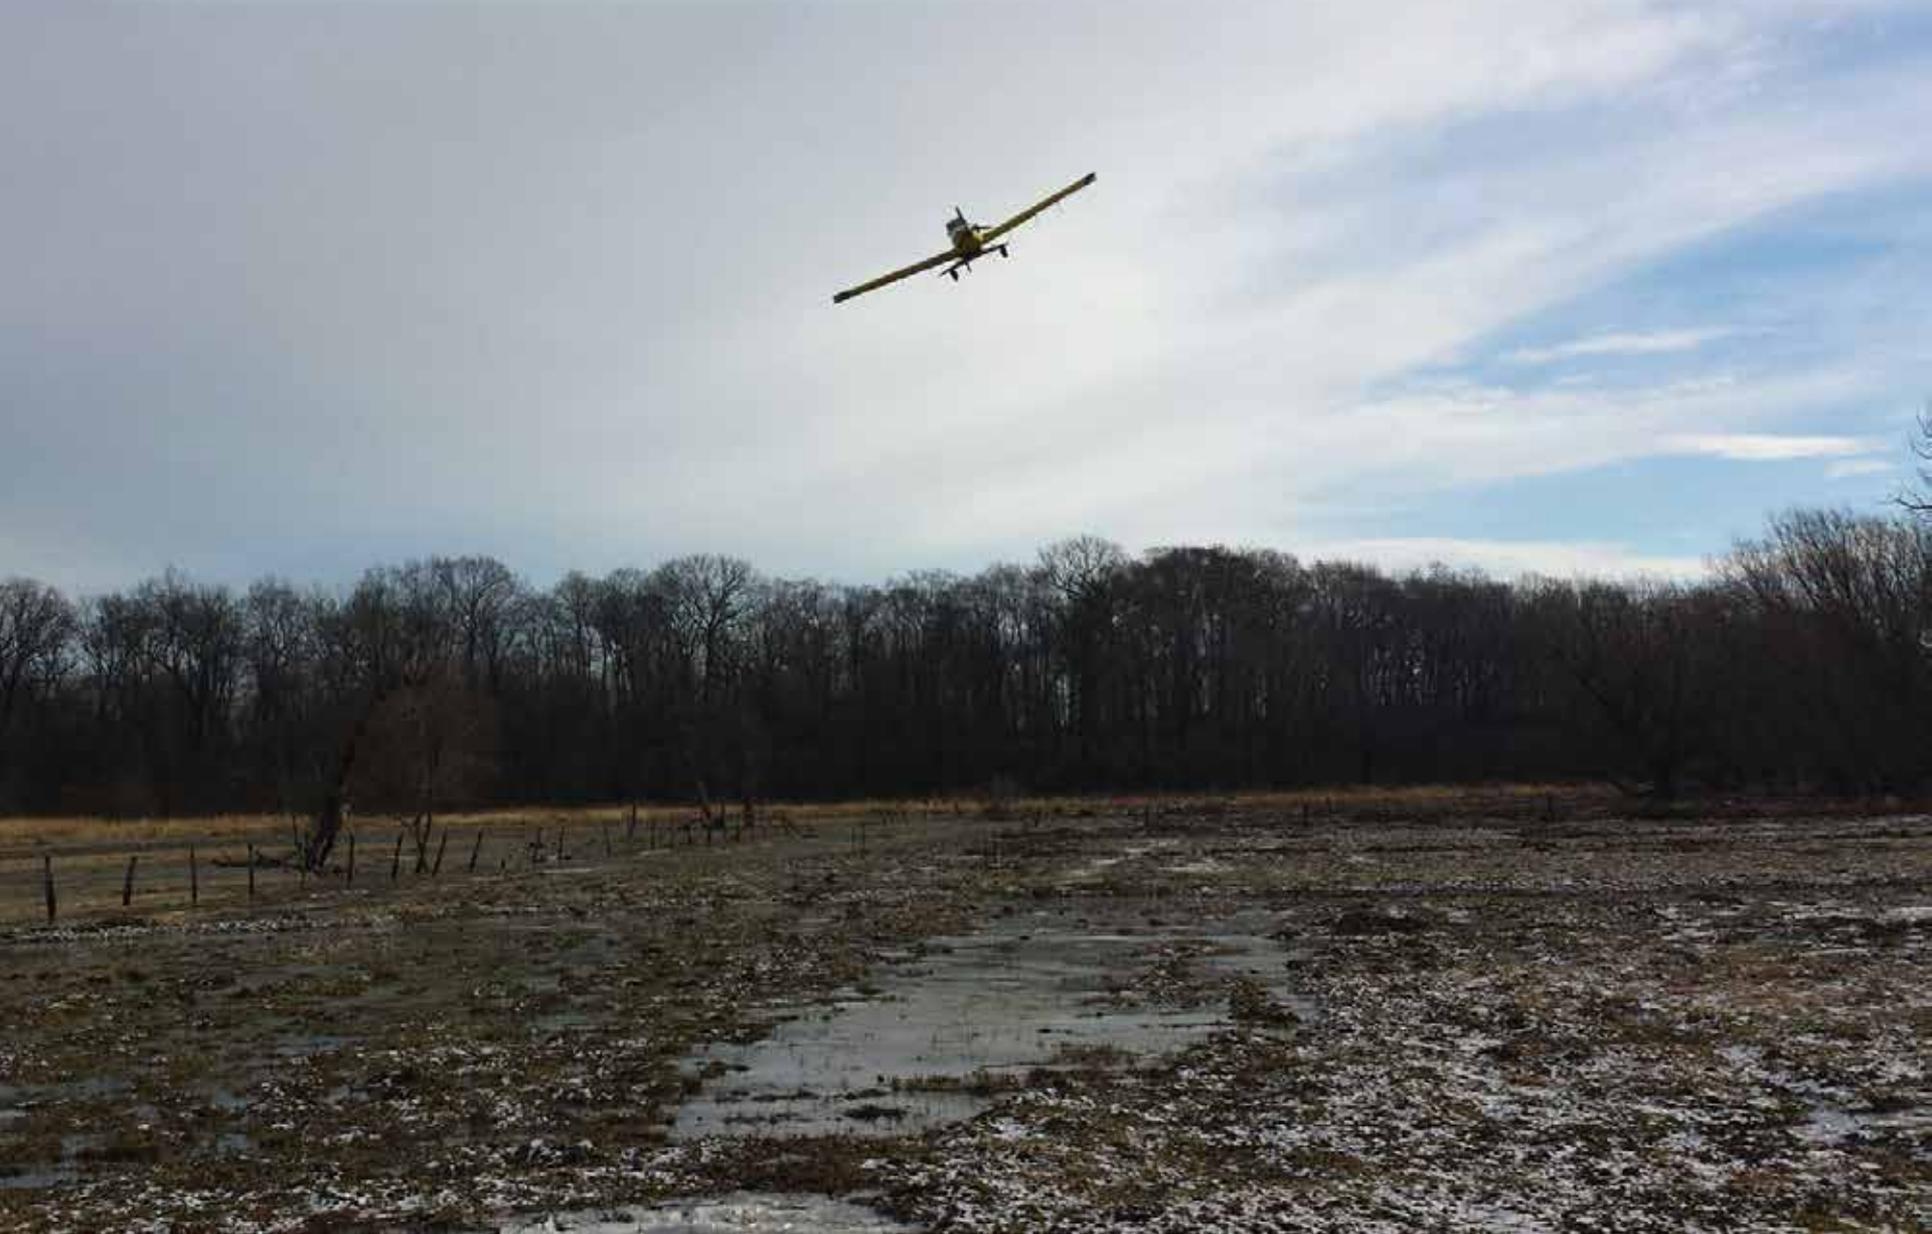
# Aerial Seeding the Emergent Species.
