# Bath Township's

## Bath Creek Floodplain / Wetland Restoration

**PROJECT NUMBER 11(h)EPA-07**

**Environmental Results:** Successful completion of the project will restore a 12-acre degraded wetland & 1,700 feet of tributary stream flowing into Bath Creek. The restoration effort is expected to reduce flooding and improve overall water quality in the Yellow Creek watershed.

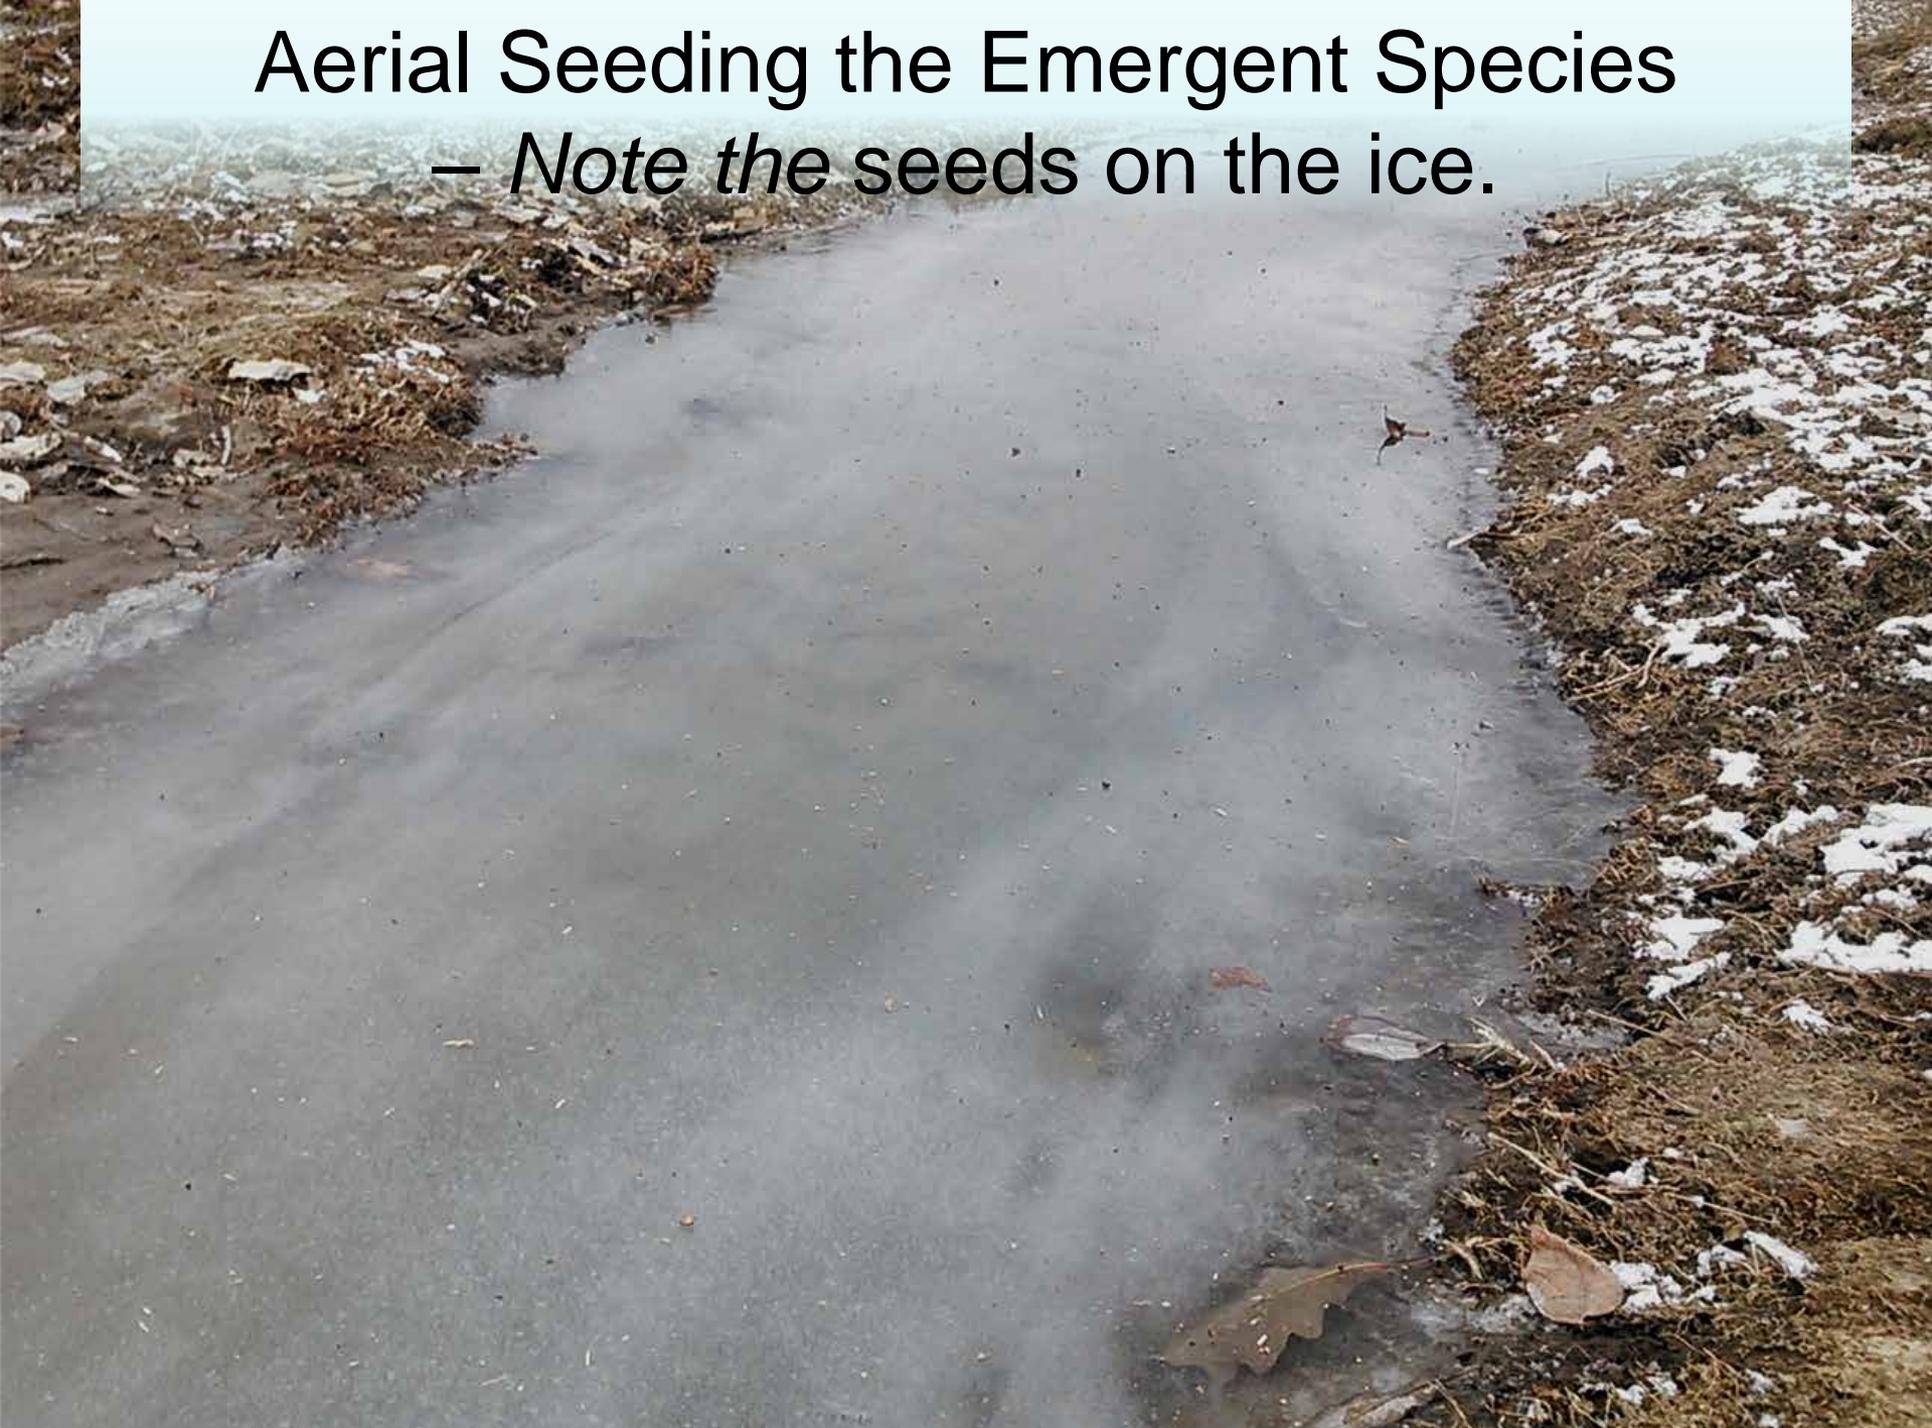
# Aerial Seeding the Emergent Species

– *Note the seeds on the ice.*

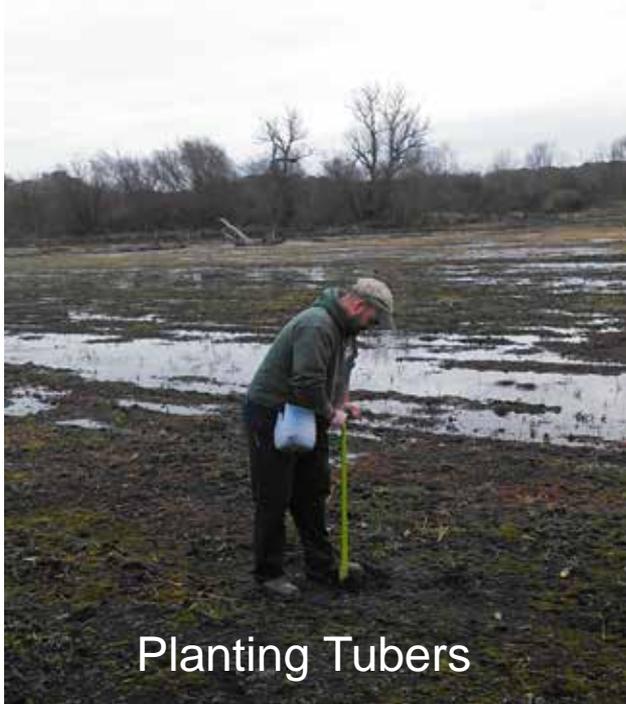
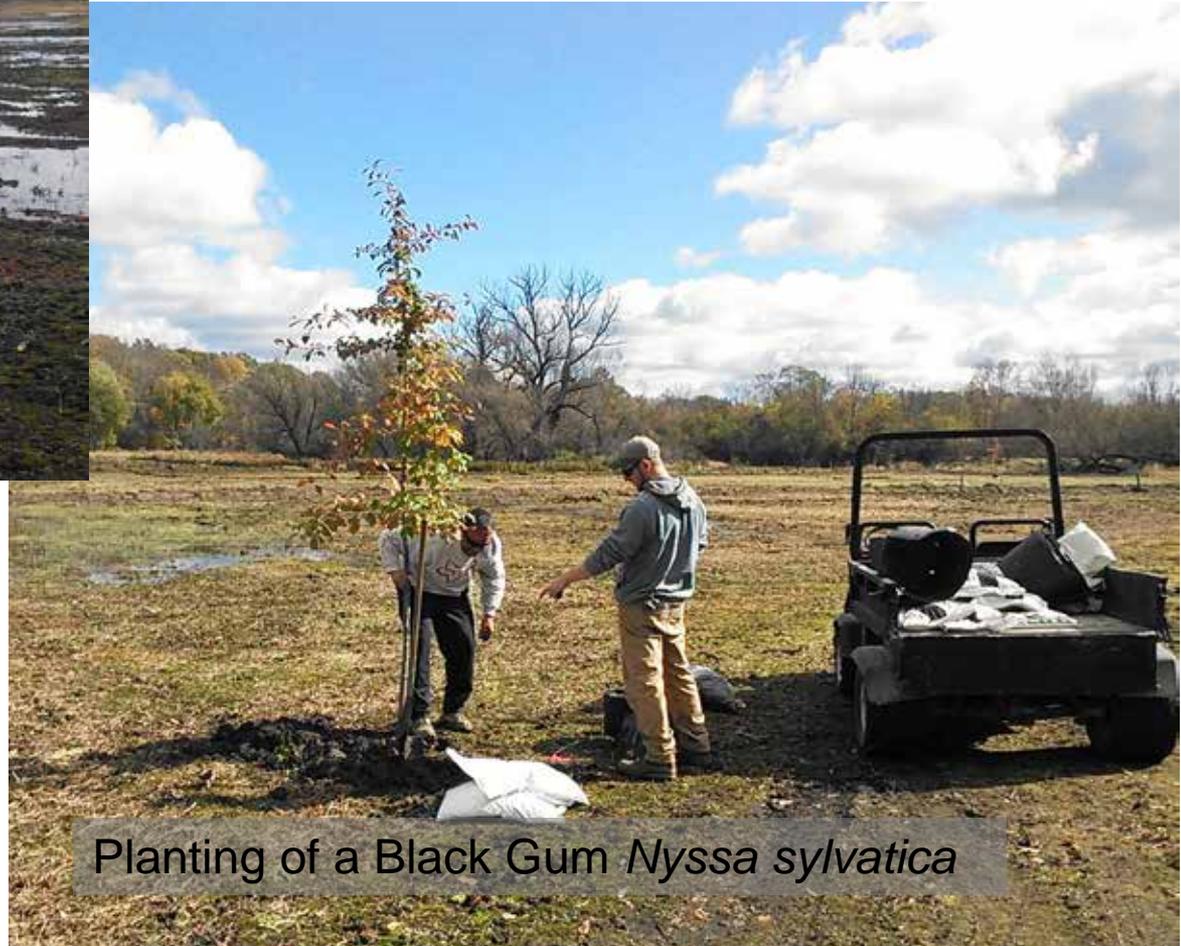
# Planting of Wetland Trees and Tubers

Planting Tubers

Bath Township Park personnel planted 22 trees consisting of both Black Willows and Black gums, 100 Bog Willows cuttings and over 200 tubers of Jerusalem Artichokes in the fall of 2014

Planting of a Black Gum *Nyssa sylvatica*
